**First Church of Christ, Woodbridge**  
**Final Report**  
*Sanctuary Repainting & Redecoration – Phase I*

December 15, 2021

**First Church of Christ, Woodbridge**  
*Historic Paint Investigation*

February 14, 2020

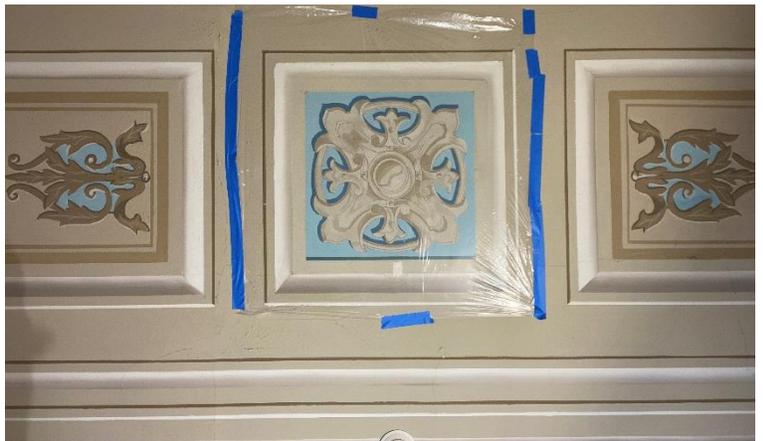
Figure 3, Existing trompe l’oeil panels before Phase I Restoration

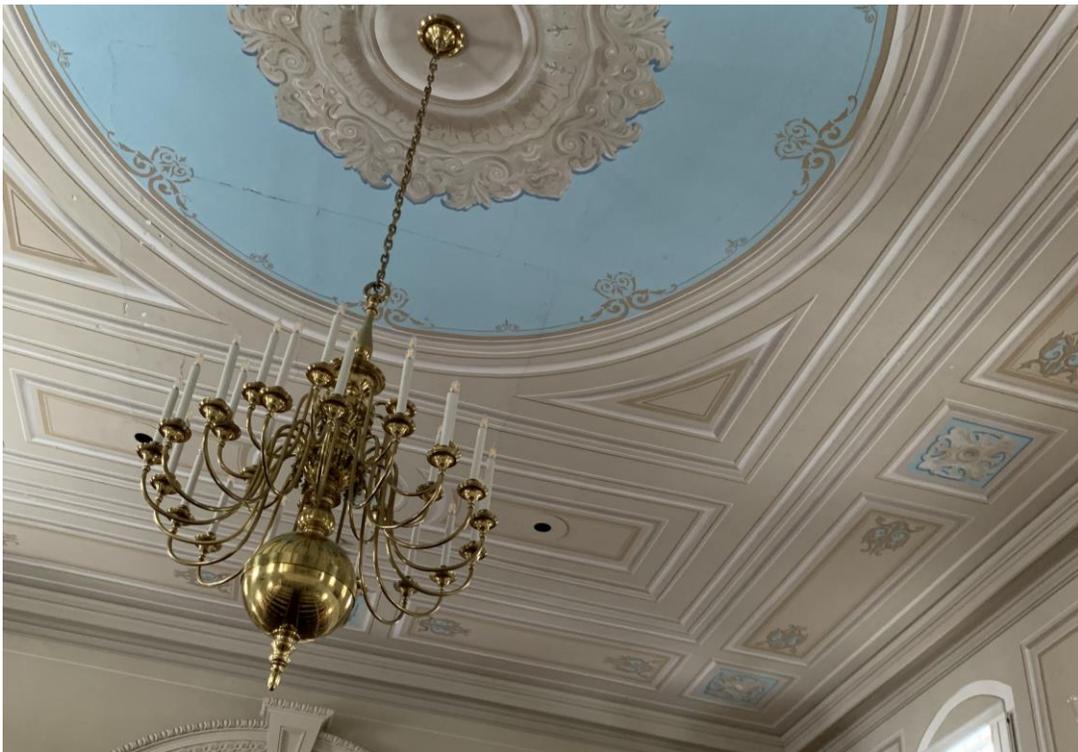
Overall, Current decorative paint campaign.

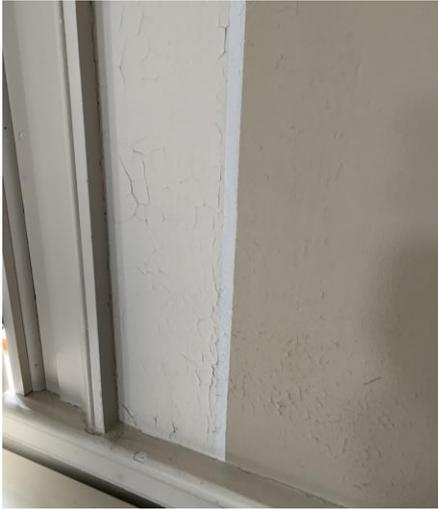
The finishes throughout the ceiling and walls are severely delaminating throughout the interior of the Sanctuary. In some cases the delamination reveals earlier decorative paint campaigns, and in other areas it reveals the original plaster substrate. Surrounding the wall sconces, previous repairs of skim coating, joint compound, mesh and/or tape are visible. Previous crack repairs are also visible at various locations at the walls on both levels. At these locations, however, the painted finish is generally adhered well. There are minimal cracks in the plaster system at the walls and failures appear to be limited to the paint coatings.

*Detail, Typical conditions of delaminating paint at the walls.*

The widespread paint failure and delamination throughout the Sanctuary is likely caused by the incompatibility between distemper and oil/emulsion paints. Distemper paints are a water-based paint that were bound with an animal based glue, such as egg or animal hide. With the building being of thin construction and not originally acclimatized, the distemper paint would have been permeable to the plaster substrate as it expanded and contracted at varying levels of moisture with the change in seasons. As distemper paints age, however, the binder begins to fail leaving a chalky and unstable finish causing finishes on top of the paint, such as the later oil/emulsions, to fail and delaminate.

1. Prior to repainting the Sanctuary, the existing finish needs to be scraped down to a stable substrate. It is unknown if the later campaigns contain a lead-based adhesive, and scraping and surface preparation should be performed by a firm certified in lead abatement and/or EPA RRP Certified.
2. Flat walls, ceilings and surfaces should be meshed and skim coated, as needed, to provide a smooth and level surface for the installation of new paint. The existing historic decorative scheme behind the organ should remain as a means for future conservation efforts and for historic significance.
3. Reinstatement a historic scheme that is sympathetic to the original decorative campaign. Using the findings of the paint investigation and historic photographs, the new design should include the original color palette and trompe l'oeil features.

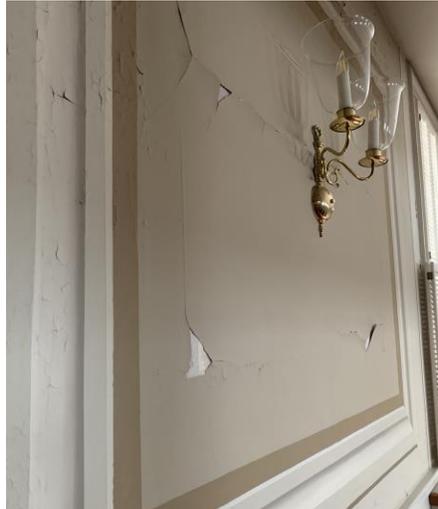
*Detail, Typical conditions of delaminating paint at the walls.*

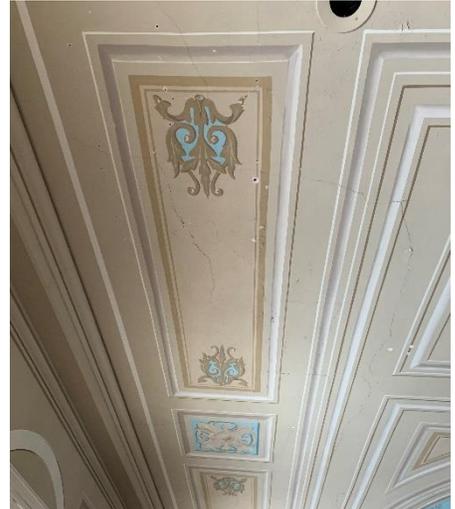
*Detail, Typical conditions of cracking and delaminating paint at the ceiling.*

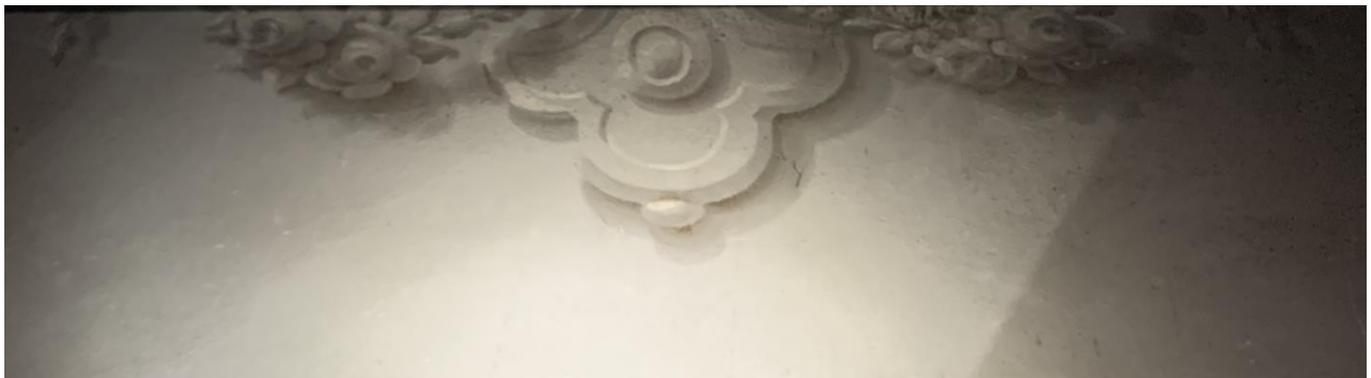
This campaign reveals a striped trompe l'oeil border above the wainscot and a trompe l'oeil cartouche, scroll, and floral garland. The color scheme consists of a paler/grayer color palette than the existing beige finish and the artistry of the trompe l'oeil features do not appear to be consistent with the current campaign, and the wainscoting below is of similar color to the wall field. A dry cleaning test was performed at this location for color matching and the decoration was documented as best as possible with the limited access. Samples were extracted at both the wall and wainscot for microscopy analysis.

*Overall, Original decoration behind organ.*

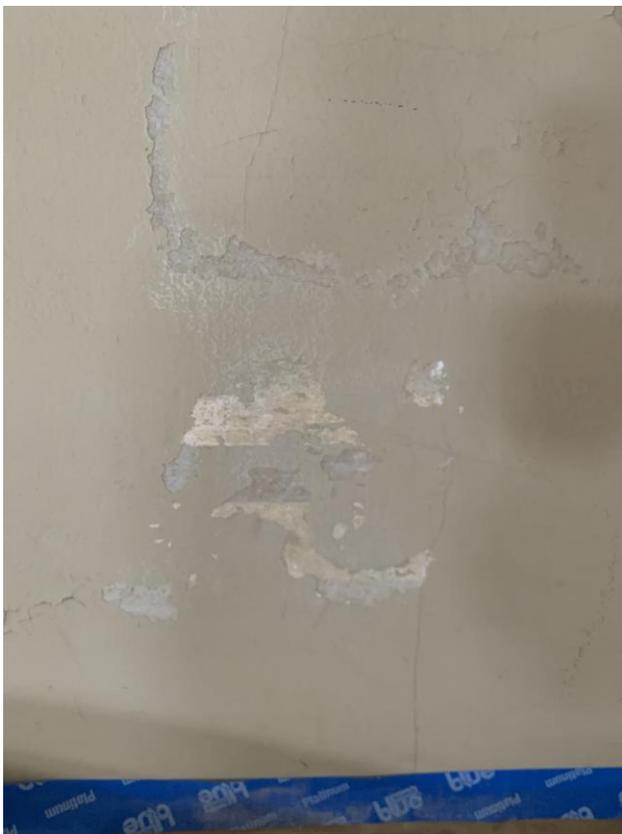
*Detail, Mechanical exposure revealing original striping.*

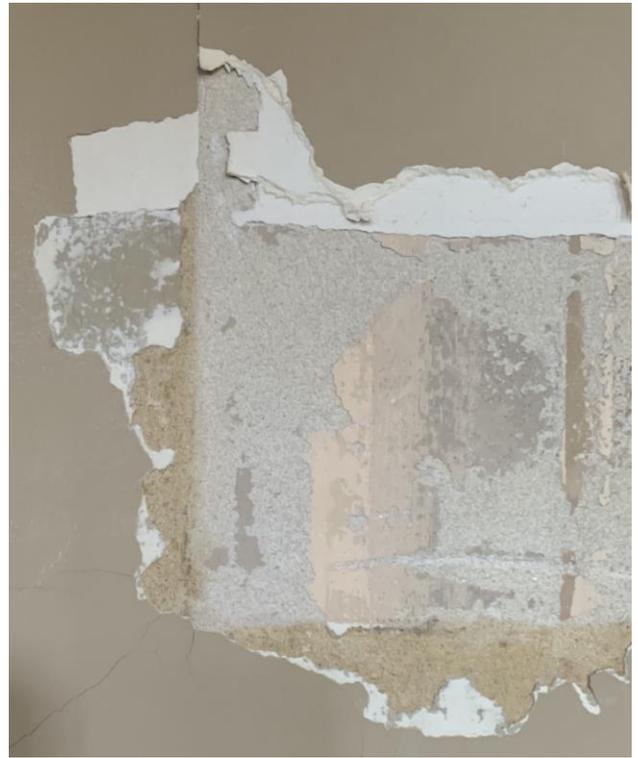
*Detail, Second and third campaign exposed beneath existing. Modern repairs/taping visible beneath existing campaign.*
