**First Church of Christ, Woodbridge**  
**Final Report**  
*Sanctuary Repainting & Redecoration – Phase I*

December 15, 2021

**First Church of Christ, Woodbridge**  
*Historic Paint Investigation*

February 14, 2020

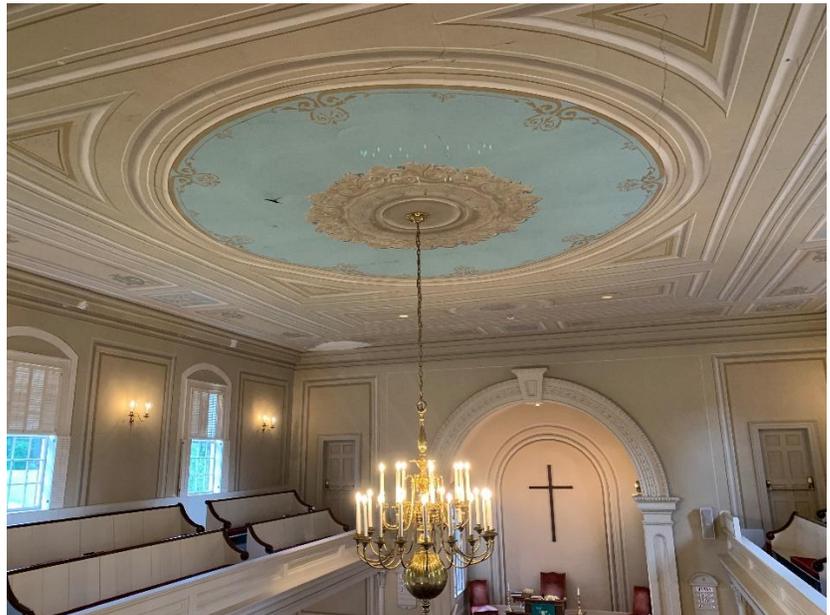
Figure 2, Existing decoration before Phase I Restoration, 2021

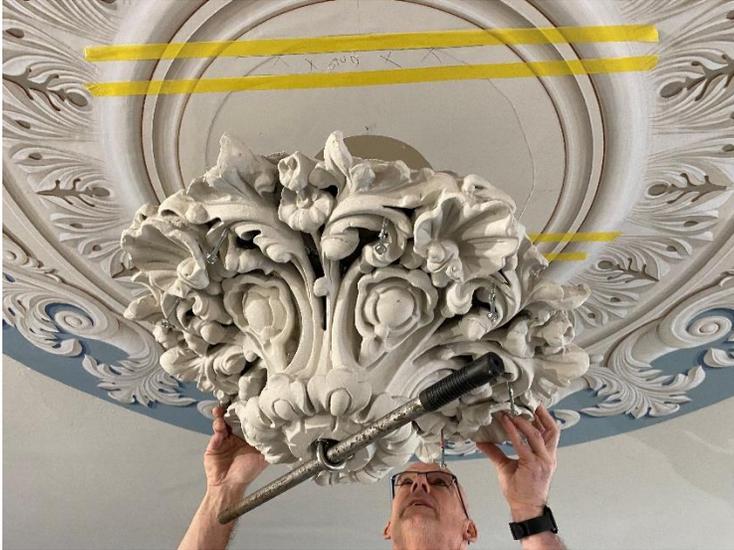
Figure 5, During JCC installation of plaster medallion

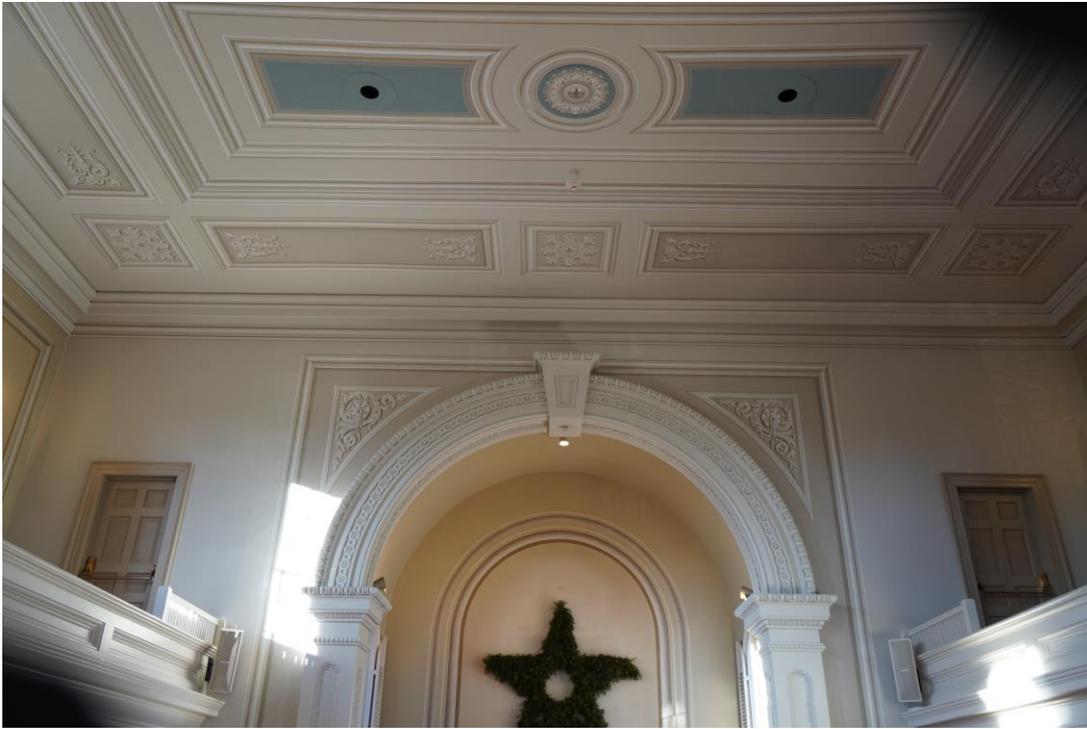
*Figure 50, Detail, After trompe l'oeil canvas installation at ceiling*

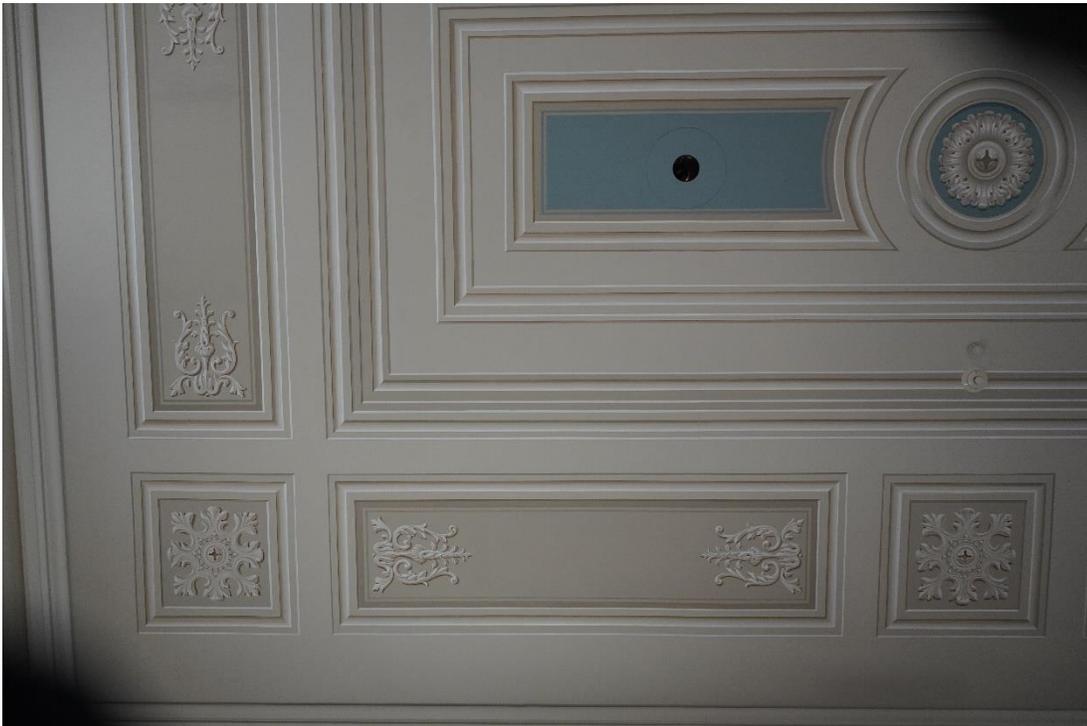
*Figure 51, Overall,  
After trompe l'oeil  
canvas installation at  
north wall & ceiling*

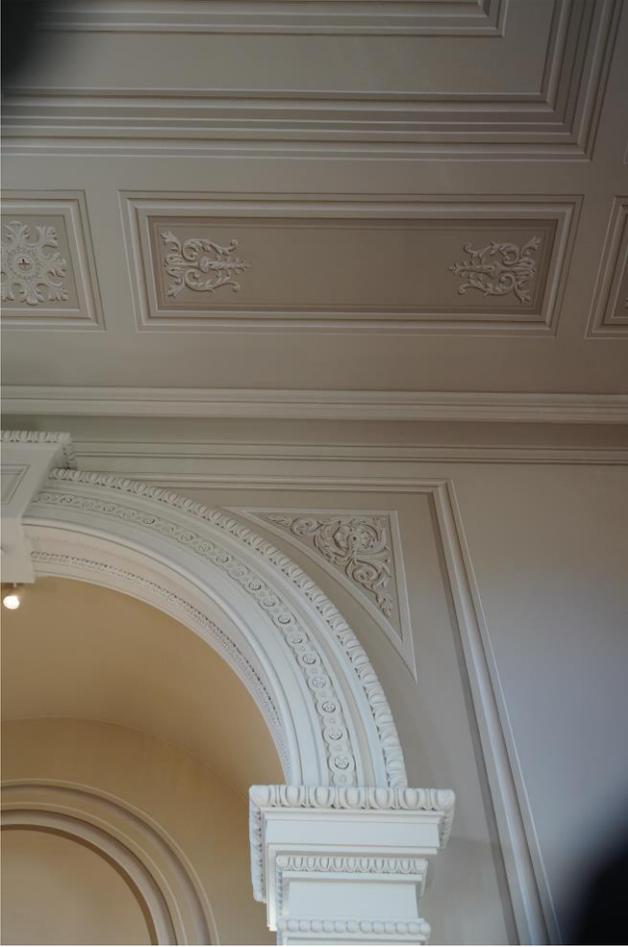
*Figure 52, Detail,  
After trompe l'oeil  
canvas installation at  
ceiling*

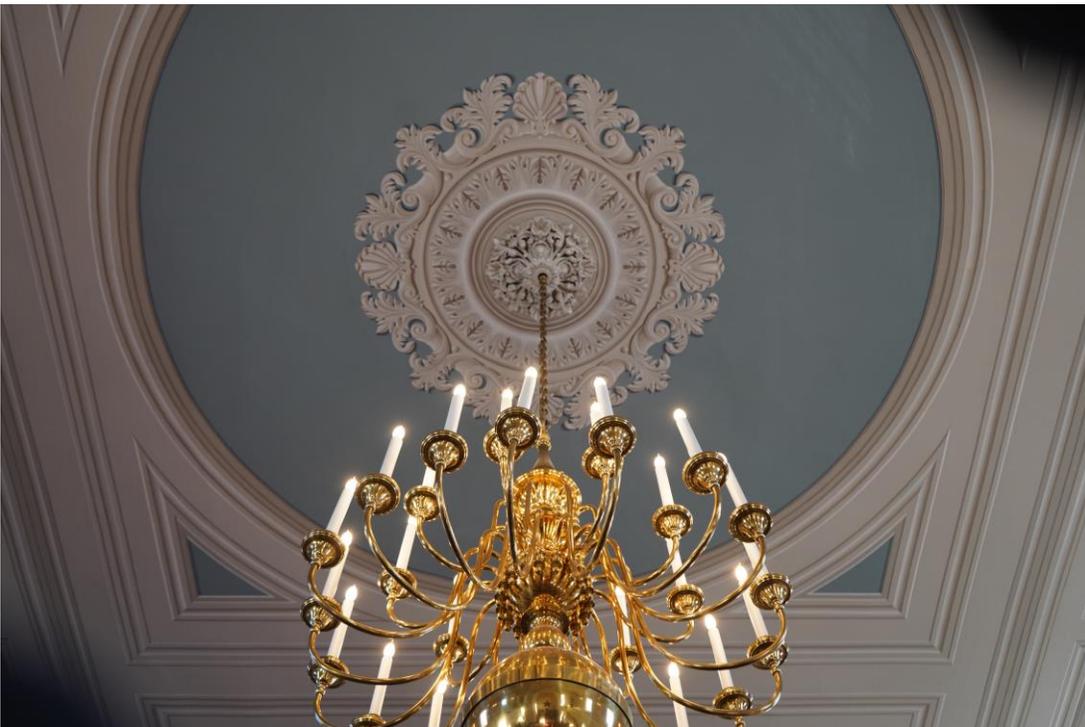
*Figure 53, Overall,  
After trompe l'oeil  
canvas installation at  
north wall*

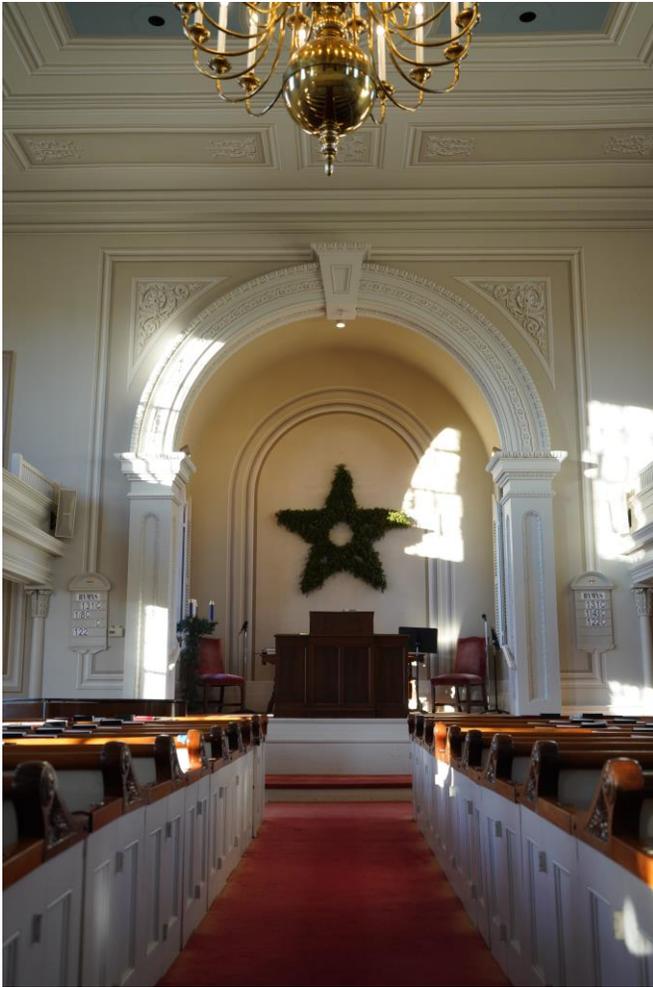
*Figure 54, Detail,  
After trompe l'oeil  
canvas installation at  
ceiling*

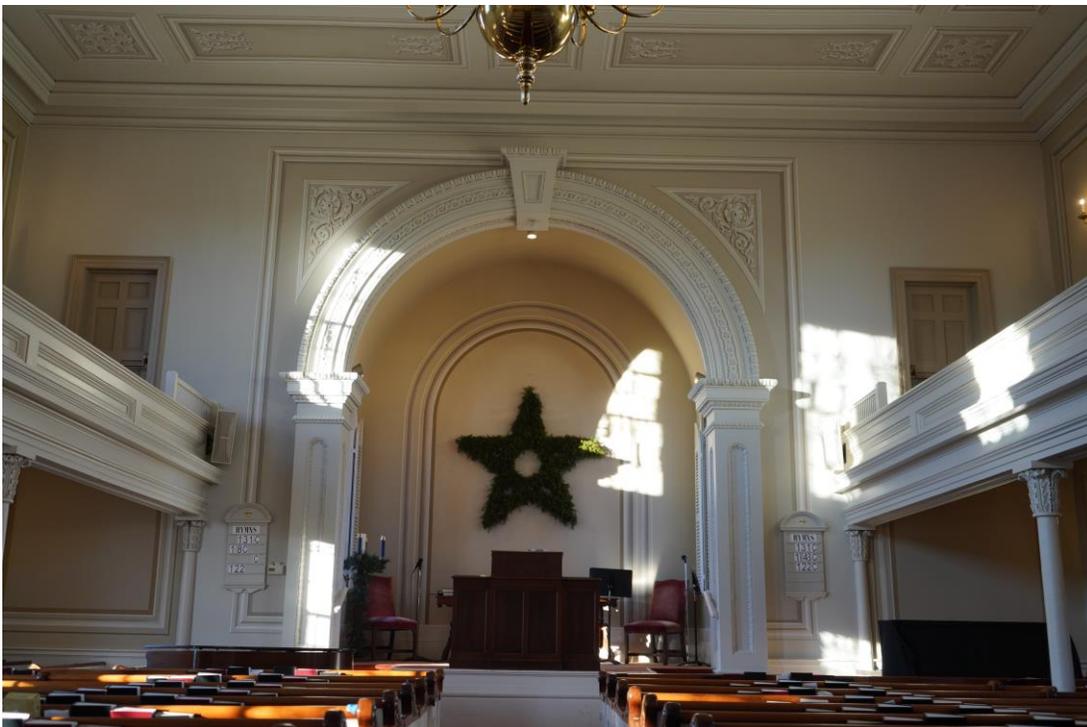
*Figure 55, Overall,  
After trompe l'oeil  
canvas installation at  
north wall*

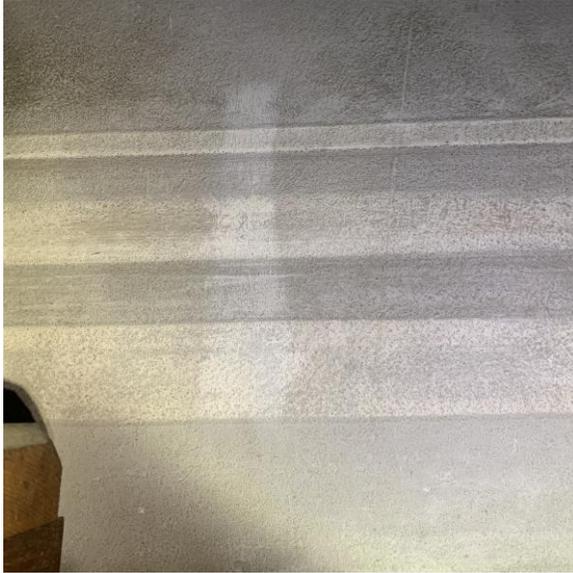
*Detail, Cleaned section of original striped border.*

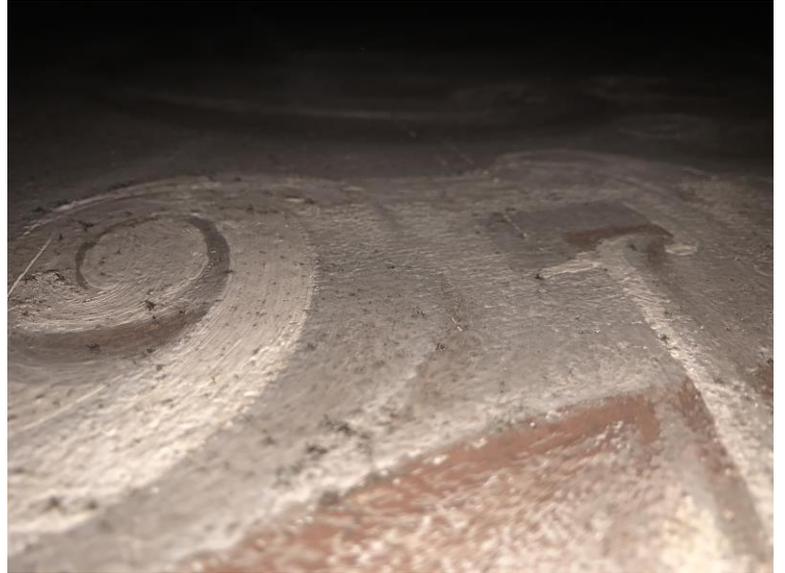
*Detail, Original trompe l'oeil decoration.*

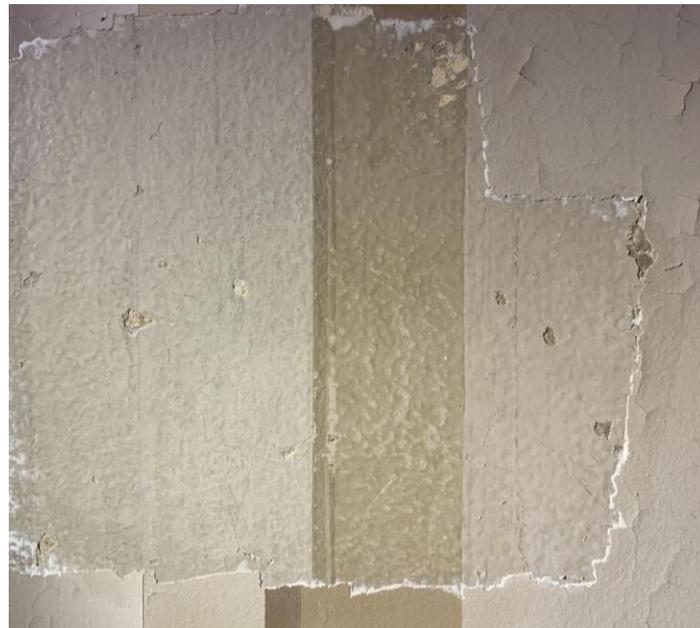
At the balcony level, exposures included mechanical and chemical exposures to further understand the paint history of the Sanctuary. Mechanical exposures were performed using a scalpel to remove existing layers of the delaminating paint. Mechanical exposures confirmed the grey field and border seen behind the organ. Chemical exposures revealed two later campaigns beneath the existing. With each decorative scheme, the design incorporated trompe l'oeil borders and the color palette seemed to transition to a warmer hue with each campaign.

*Detail, mechanical exposure of earlier decorative paint campaign.*

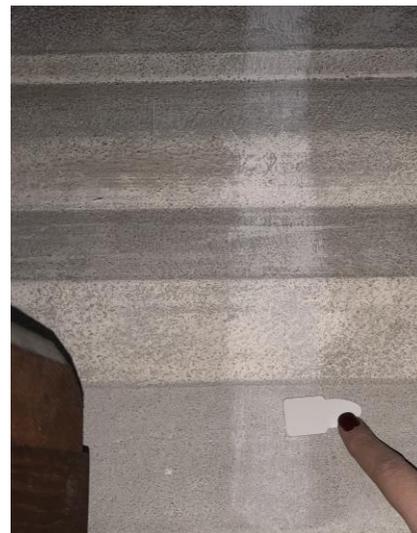
*Overall, Color matching striped border.*

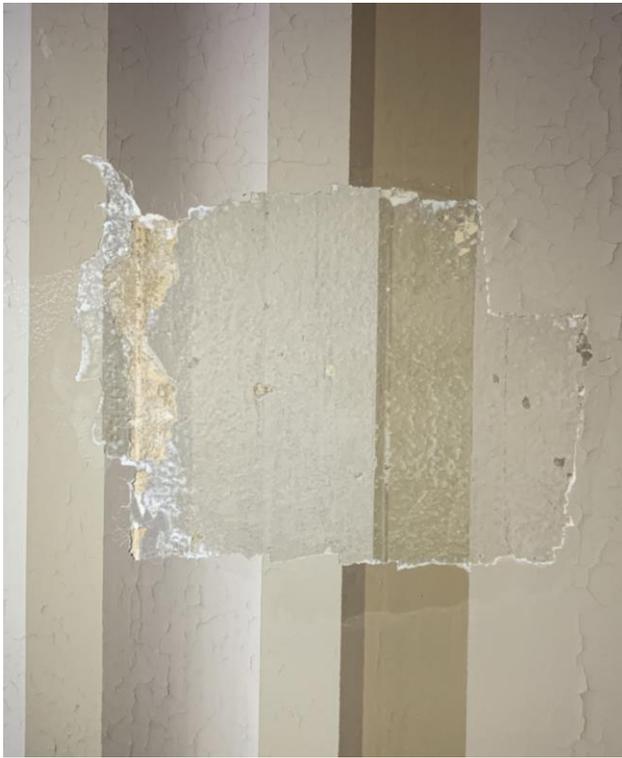
*Detail, Third campaign exposed beneath existing campaign.*
